Hazen *Technical Memorandum*

January 22, 2019

Mason Farm WWTP 2017-2018 Secondary Treatment Evaluations Compilation TM

Compilation TM Appendix A:
Mason Farm WWTP Secondary
Clarifier Rehabilitation Study -
Final

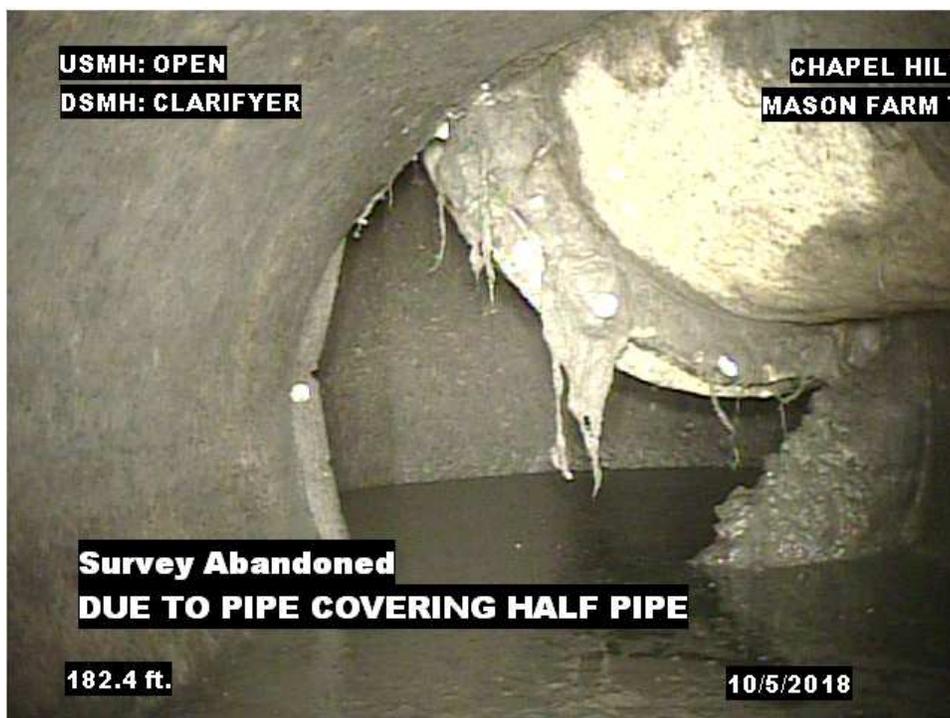
Figure 2-1: Clarifier 1 Pipe Survey

OWASA determined that the next step would be to reduce the water level in the centerwell to identify any obstructions located in the clarifier center column. Therefore, in October 2018, Vision NC returned to the Mason Farm WWTP and worked with OWASA Maintenance staff to perform a complete inspection of the influent pipe to Secondary Clarifier 1. During the second inspection, no hydraulic

restrictions were identified in the influent pipe; any foam or grease that had built up in the pipe may have washed out during Hurricane Florence. The most significant discovery from this inspection, however, was the obstruction in the influent pipe where it connects to the clarifier centerwell, as shown in **Figure 2-1**. The pipe shown at the top of the figure is the 18-inch RAS pipe which protrudes into the 24-inch influent pipe. Additionally, there appears to be a buildup of grease and rags located in the lower-right portion of the pipe circumference that would even further restrict clarifier influent flow. The combination of these two obstructions appear to reduce the pipe cross-sectional area by at least one third. Since the pipe protrusion is not portrayed in the secondary clarifier drawings, the minor loss K-factor associated with this obstruction was not accounted for when developing the hydraulic profile for the Mason Farm WWTP. The findings of this inspection does explain why Clarifier 1 receives less flow than what it is rated for, and generally receives less flow than Clarifiers 4 and 5 as observed by plant staff.

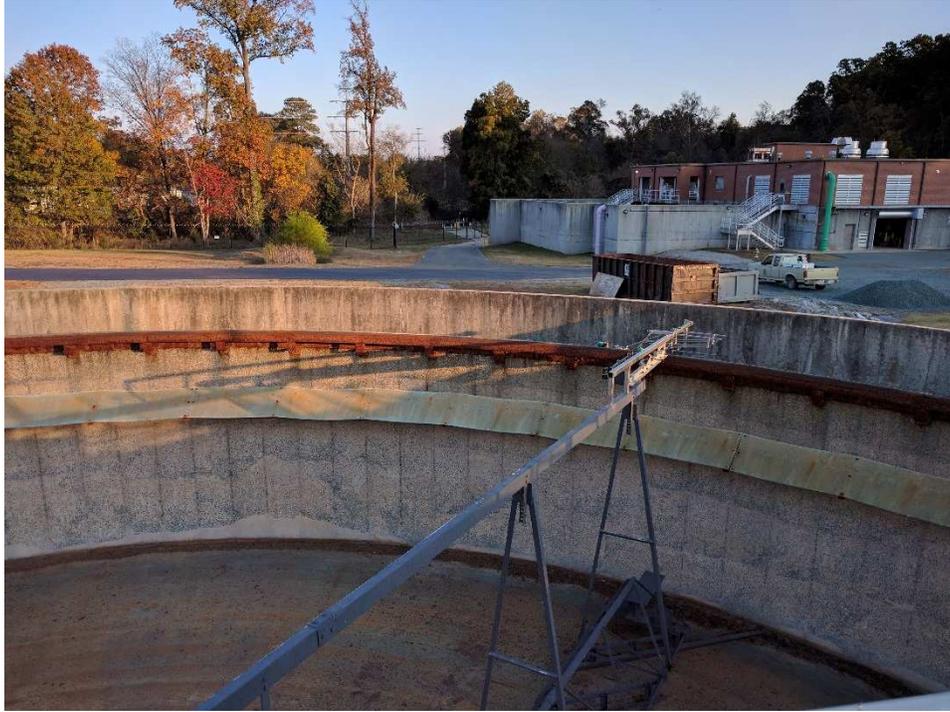
Worn Stamford Baffles – Clarifiers 2&3

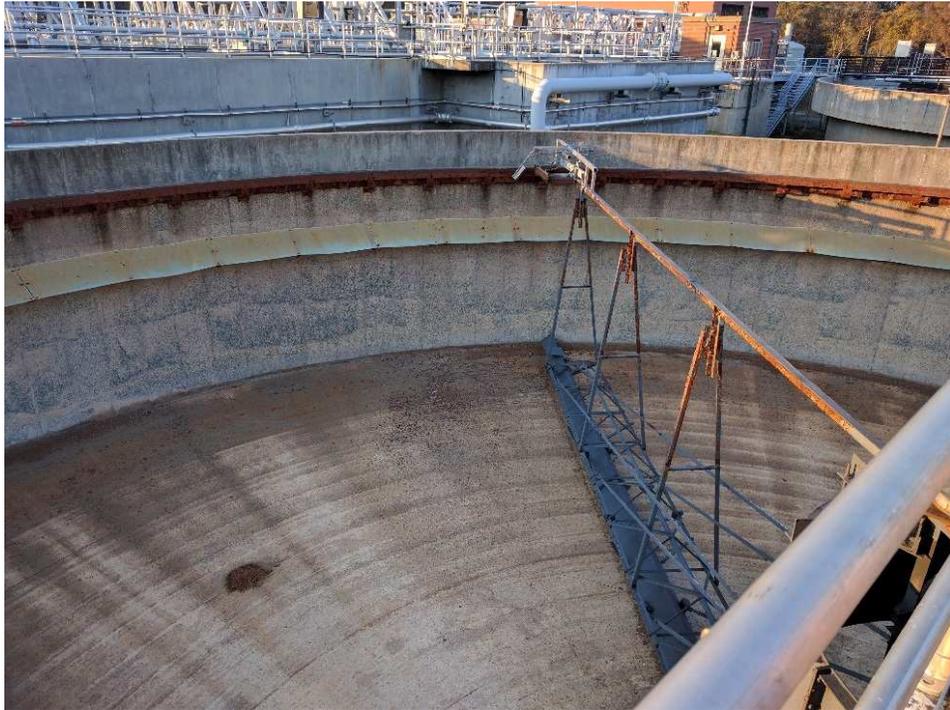
Divots in Concrete due to Unstable Centerwell – Clarifiers 2&3

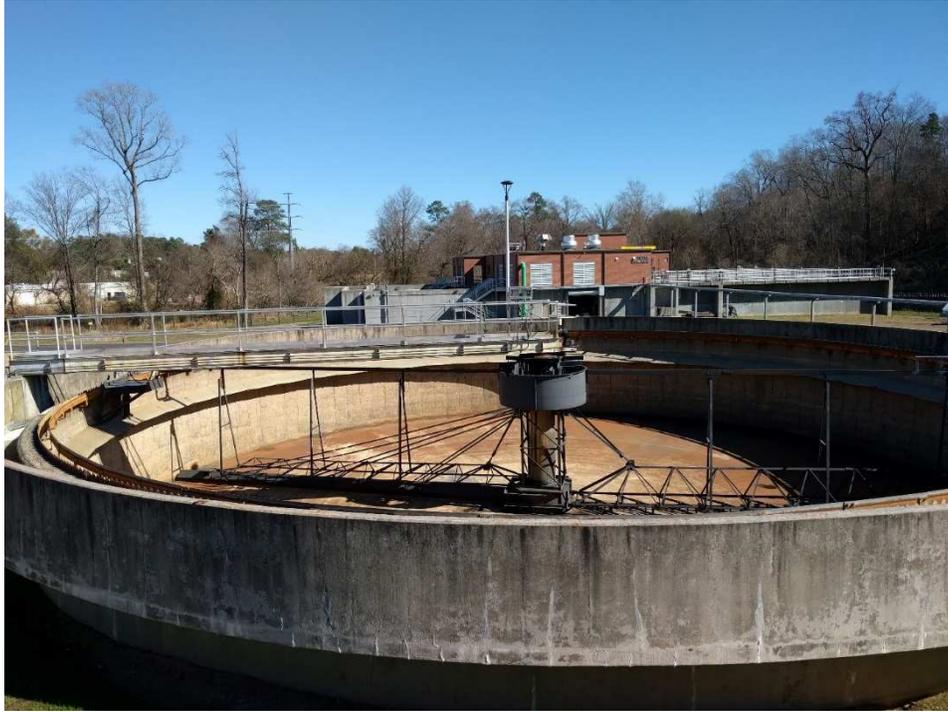
Undersized Centerwell with No Scum Ports - Clarifiers 2&3

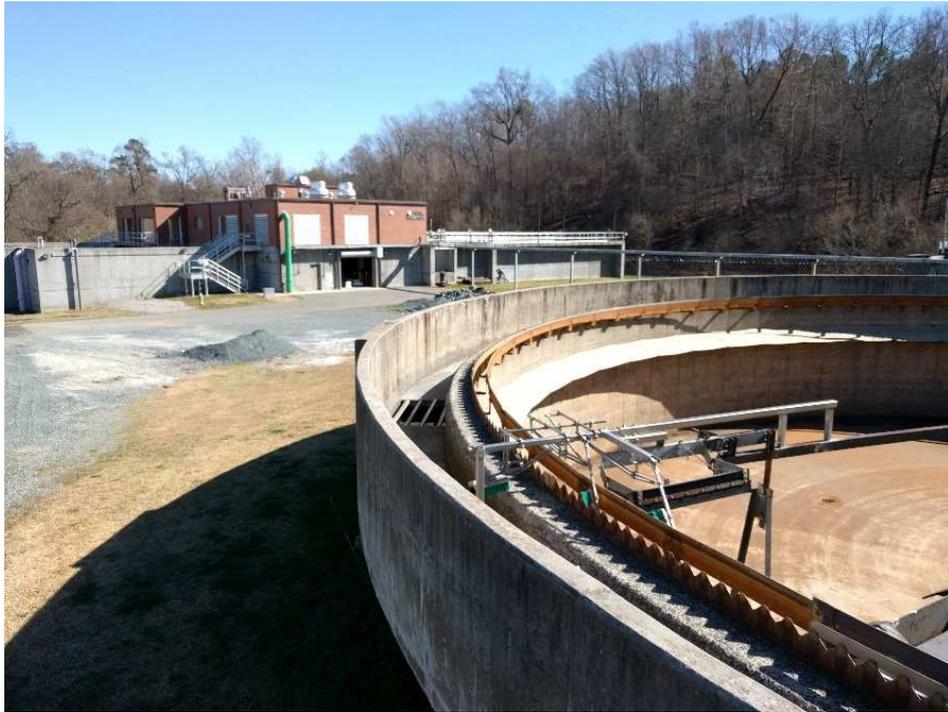
Corroded Weir Plates – Clarifiers 2&3

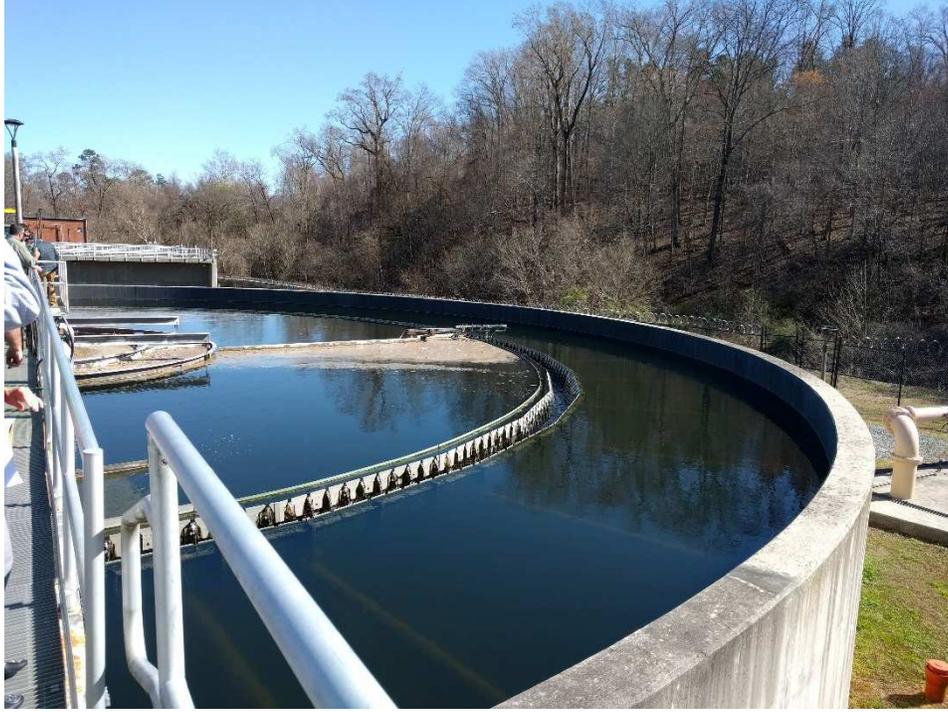
Inboard Effluent Launder – Clarifier 4

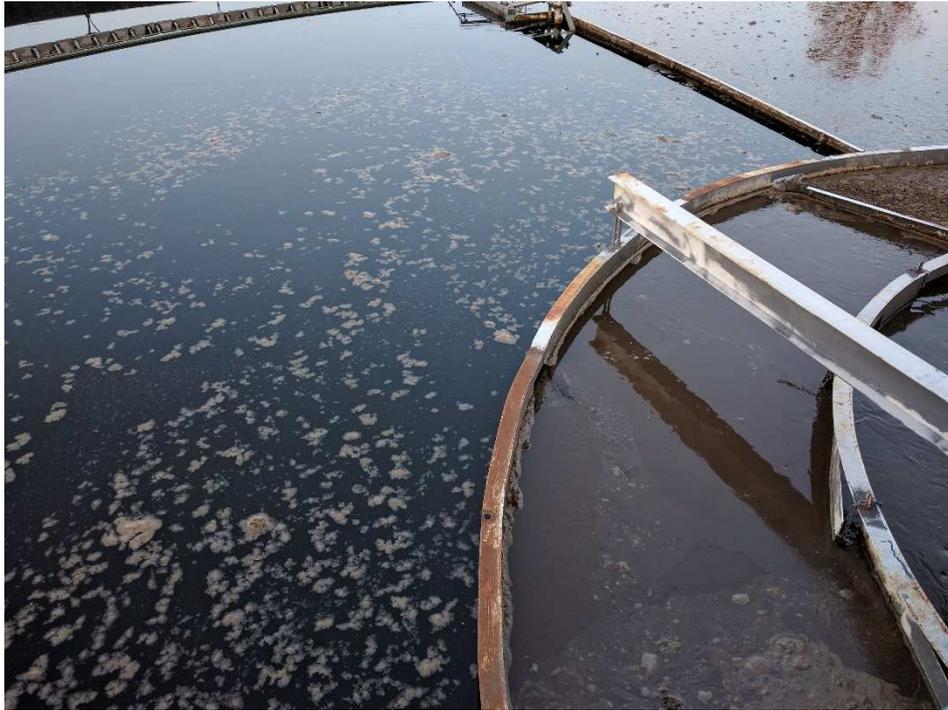
Scum Accumulation – Clarifier 4

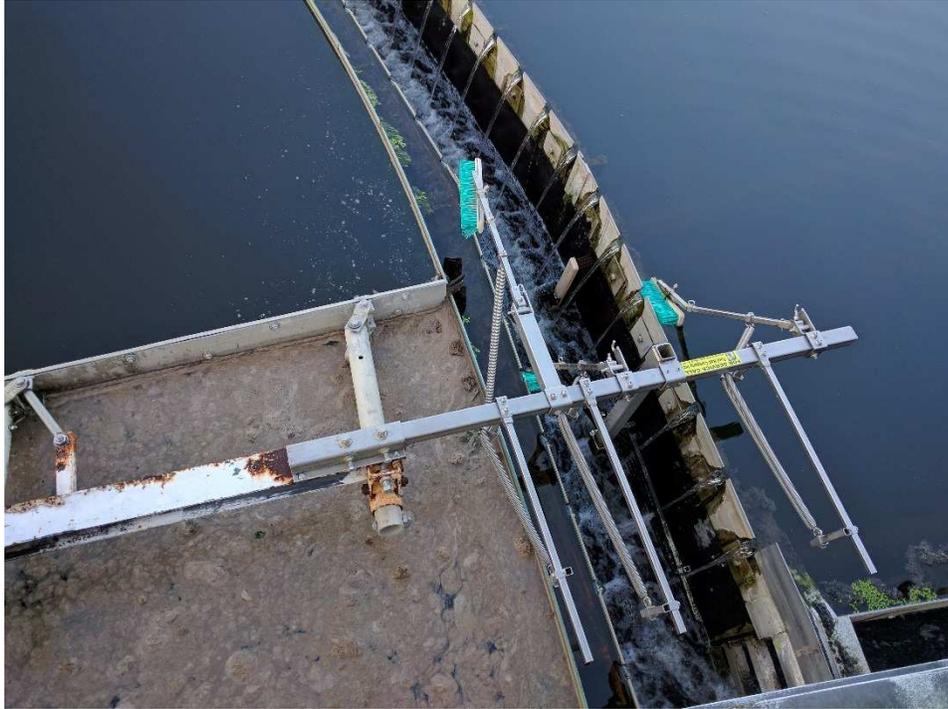
Weir Brush System – Clarifier 4

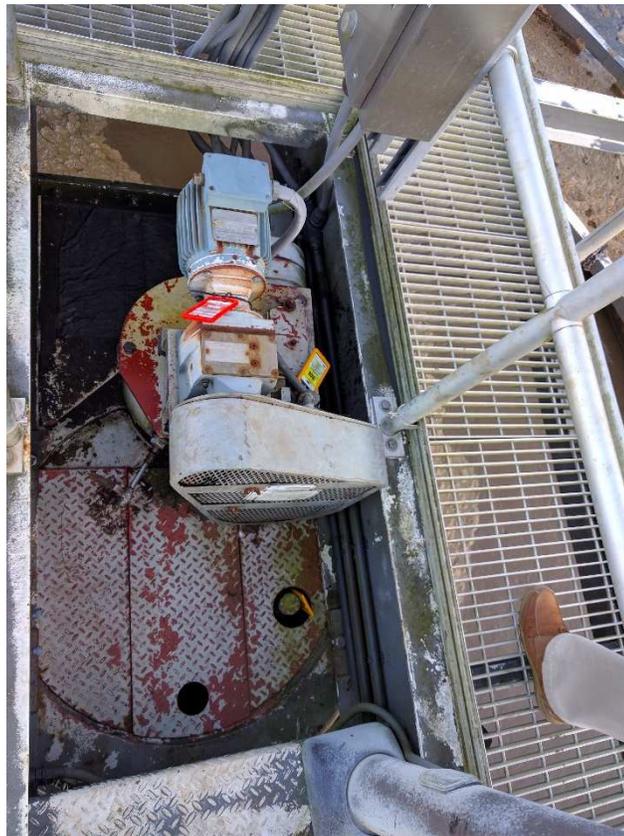
Clarifier Mechanism – Clarifier 4

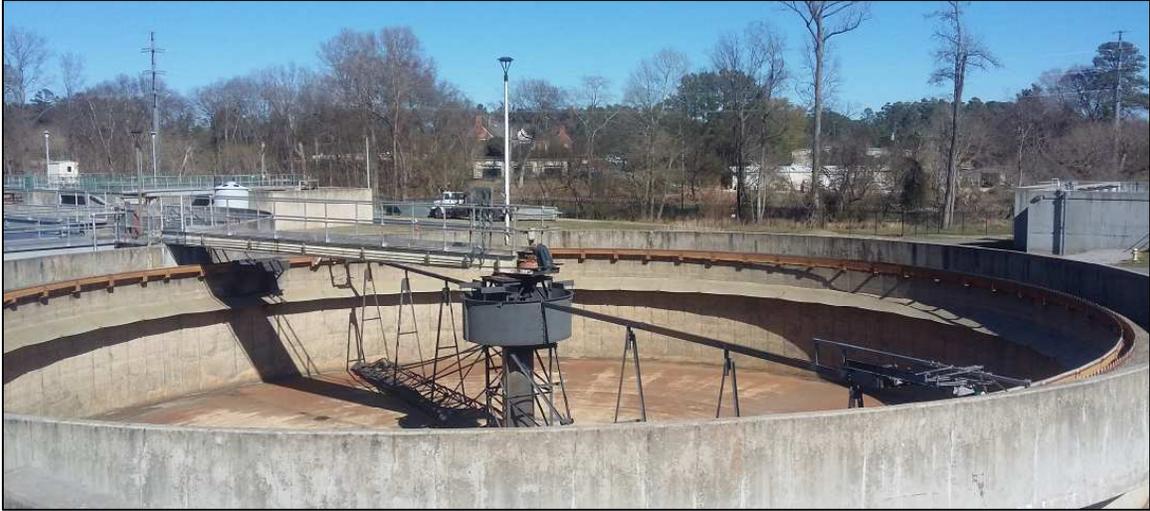
Photo 1: Envirex clarifier not in operation

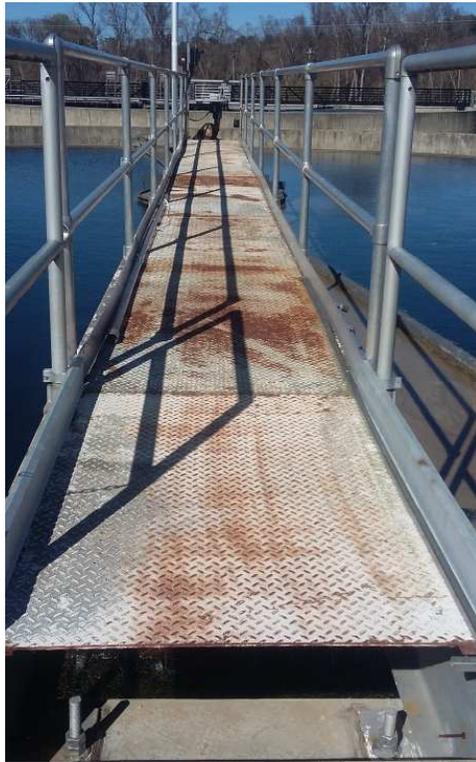
Photo 3: The above photo shows the poor condition of the existing checker plate

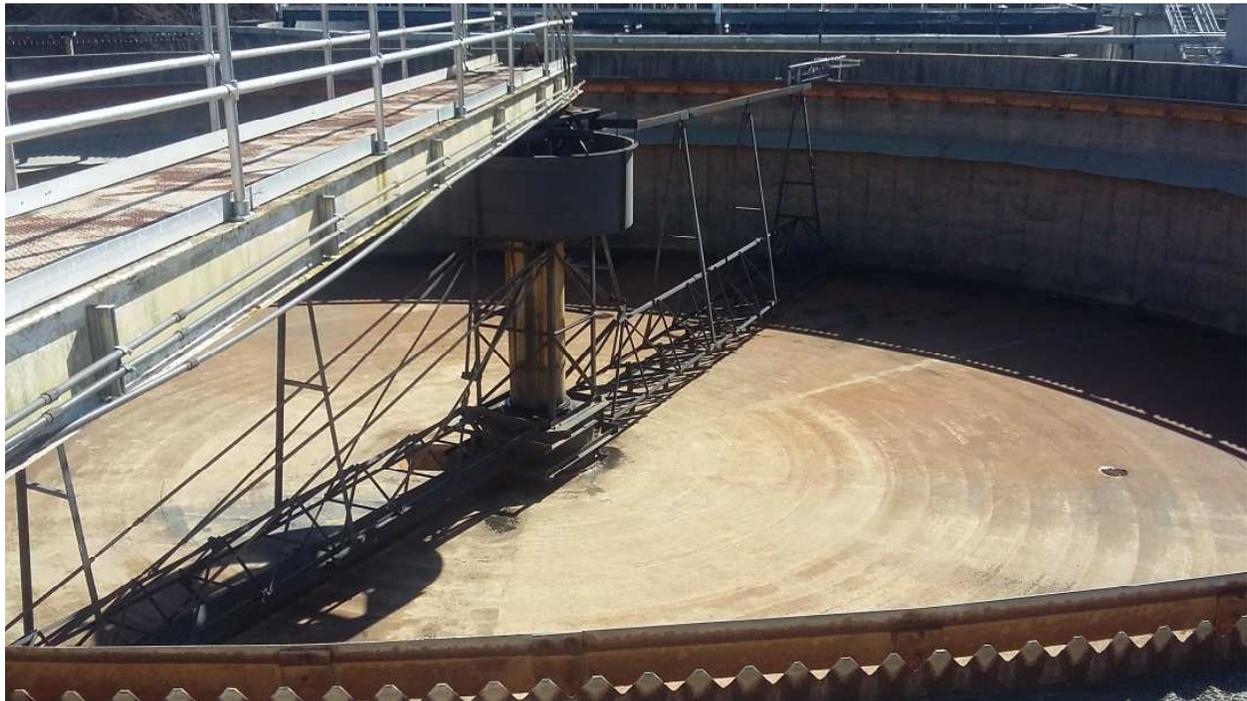
Photo 4: Envirex clarifier out of operation. Grooves are visible on the floor from the plow blades

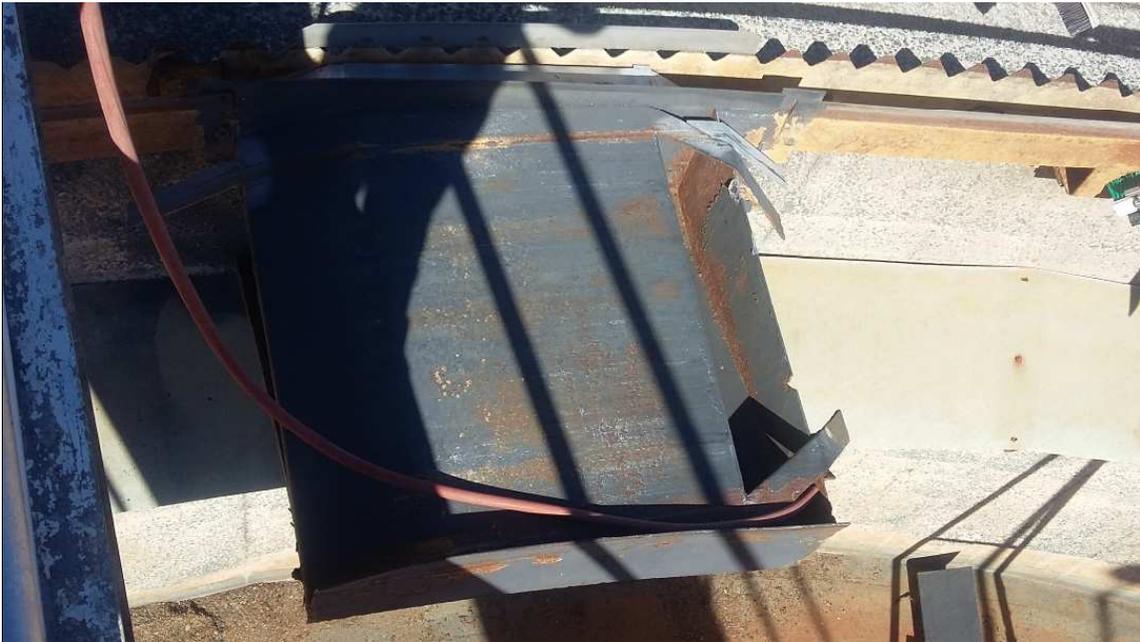
Photo 5: The scum troughs of both Envirex clarifiers are in a poor shape. Manual hoses are needed to complete flushing of the scum.

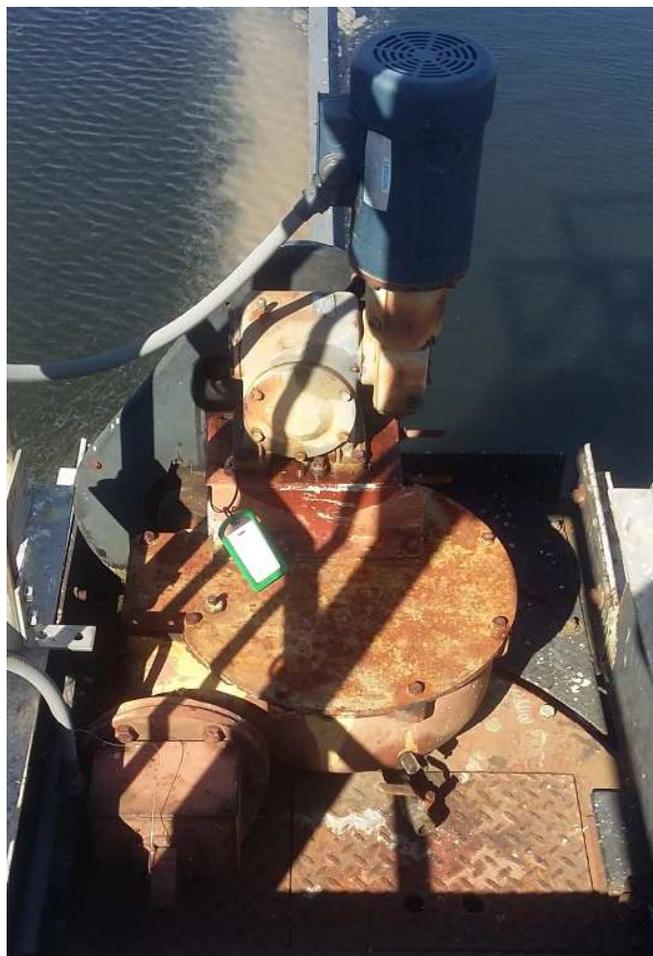
Photo 6: The drives for both clarifiers are in poor shape after operating for almost double their design life.

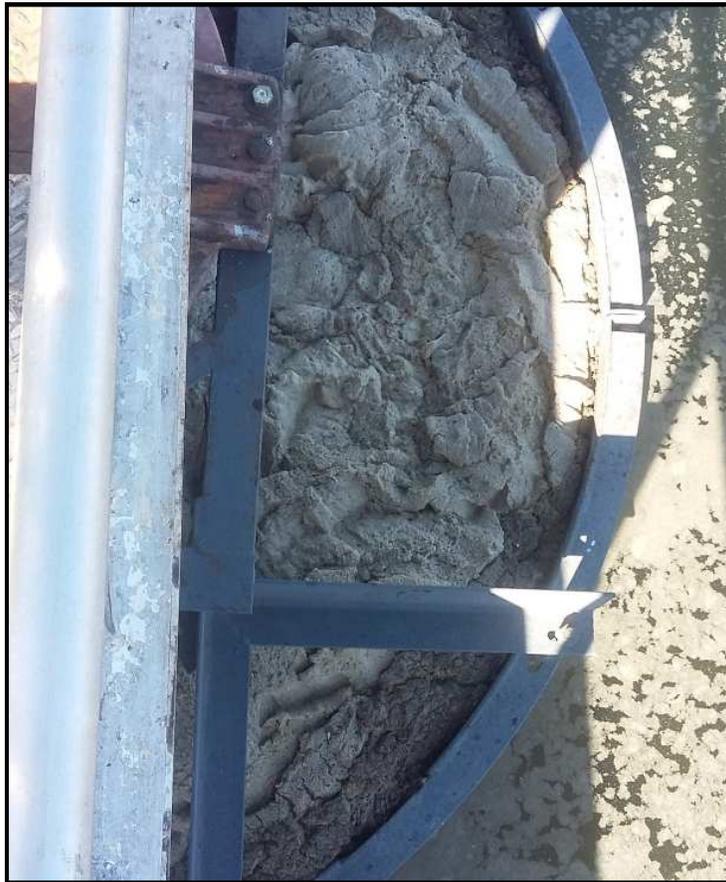
Photo 7: The existing influent well has a diameter of 8'-5". This is approximately $\frac{1}{2}$ the size recommended for use. The purposed equipment would have an influent well of 19'-9" along with the Envirex patent FEDWA EDI.

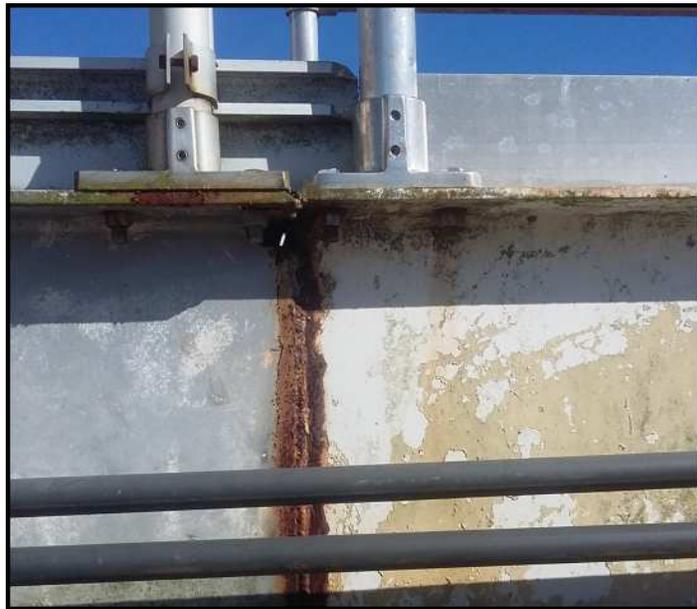
Photo 8: During the installation of the Algae Sweep/ Weir-Wolf Brush systems by Ford Hall Company, an additional section of beam bridge was added to the existing Envirex equipment.

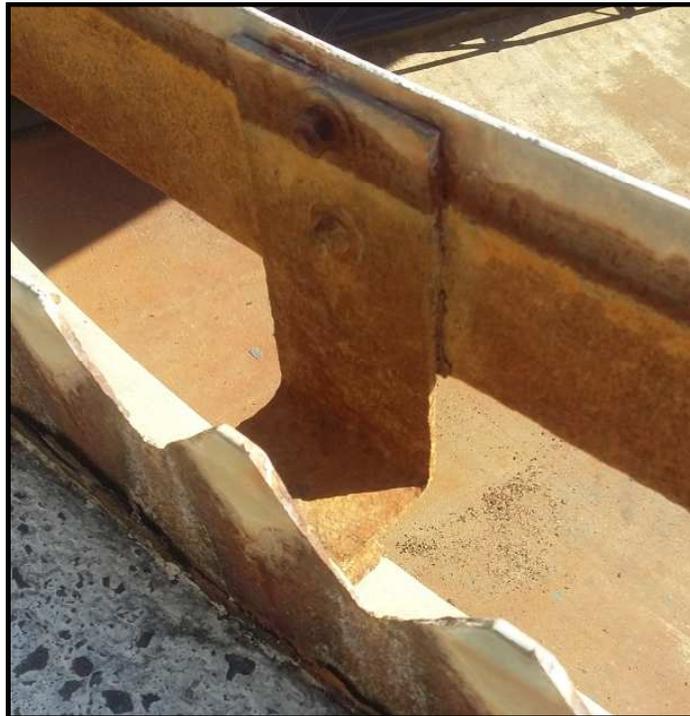
Photo 9: The current metal weirs and baffles are in a state of disrepair and need to be replacement.

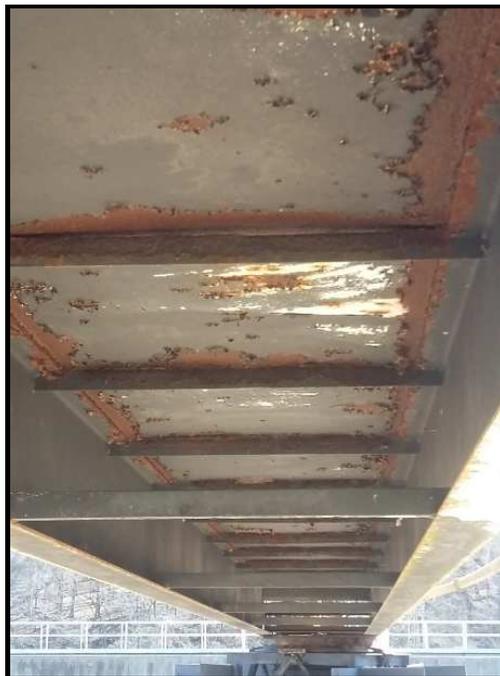
Photo 10: Severe rust is seen on the underside of the checker plate

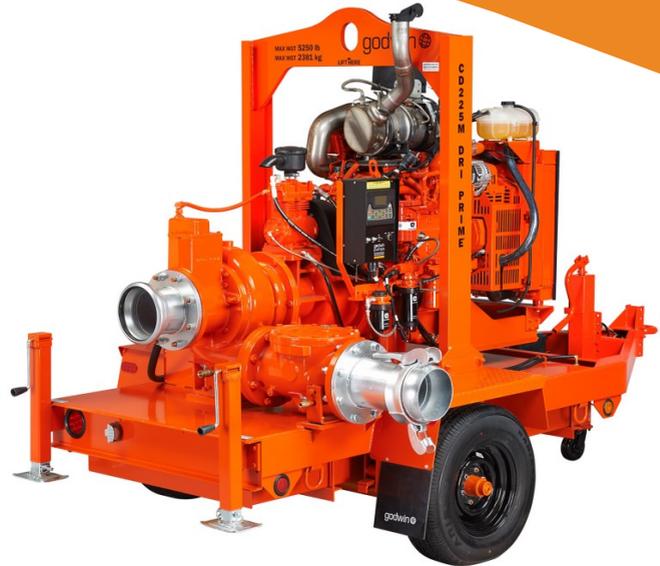
The CD225M is able to automatically prime to 28' of suction lift from dry. Automatic or manual starting/stopping available through integral mounted control panel or optional wireless-remote access.

Indefinite dry-running is no problem due to the unique Godwin liquid bath mechanical seal design. Solids handling, dry-running, and portability make the CD225M the perfect choice for dewatering and bypass applications.
